MacArthur Maze and Newhall Pass Fires and their Implications for Spent Fuel Transport

Christopher S. Bajwa, Earl P. Easton
U.S. Nuclear Regulatory Commission,
Washington, DC

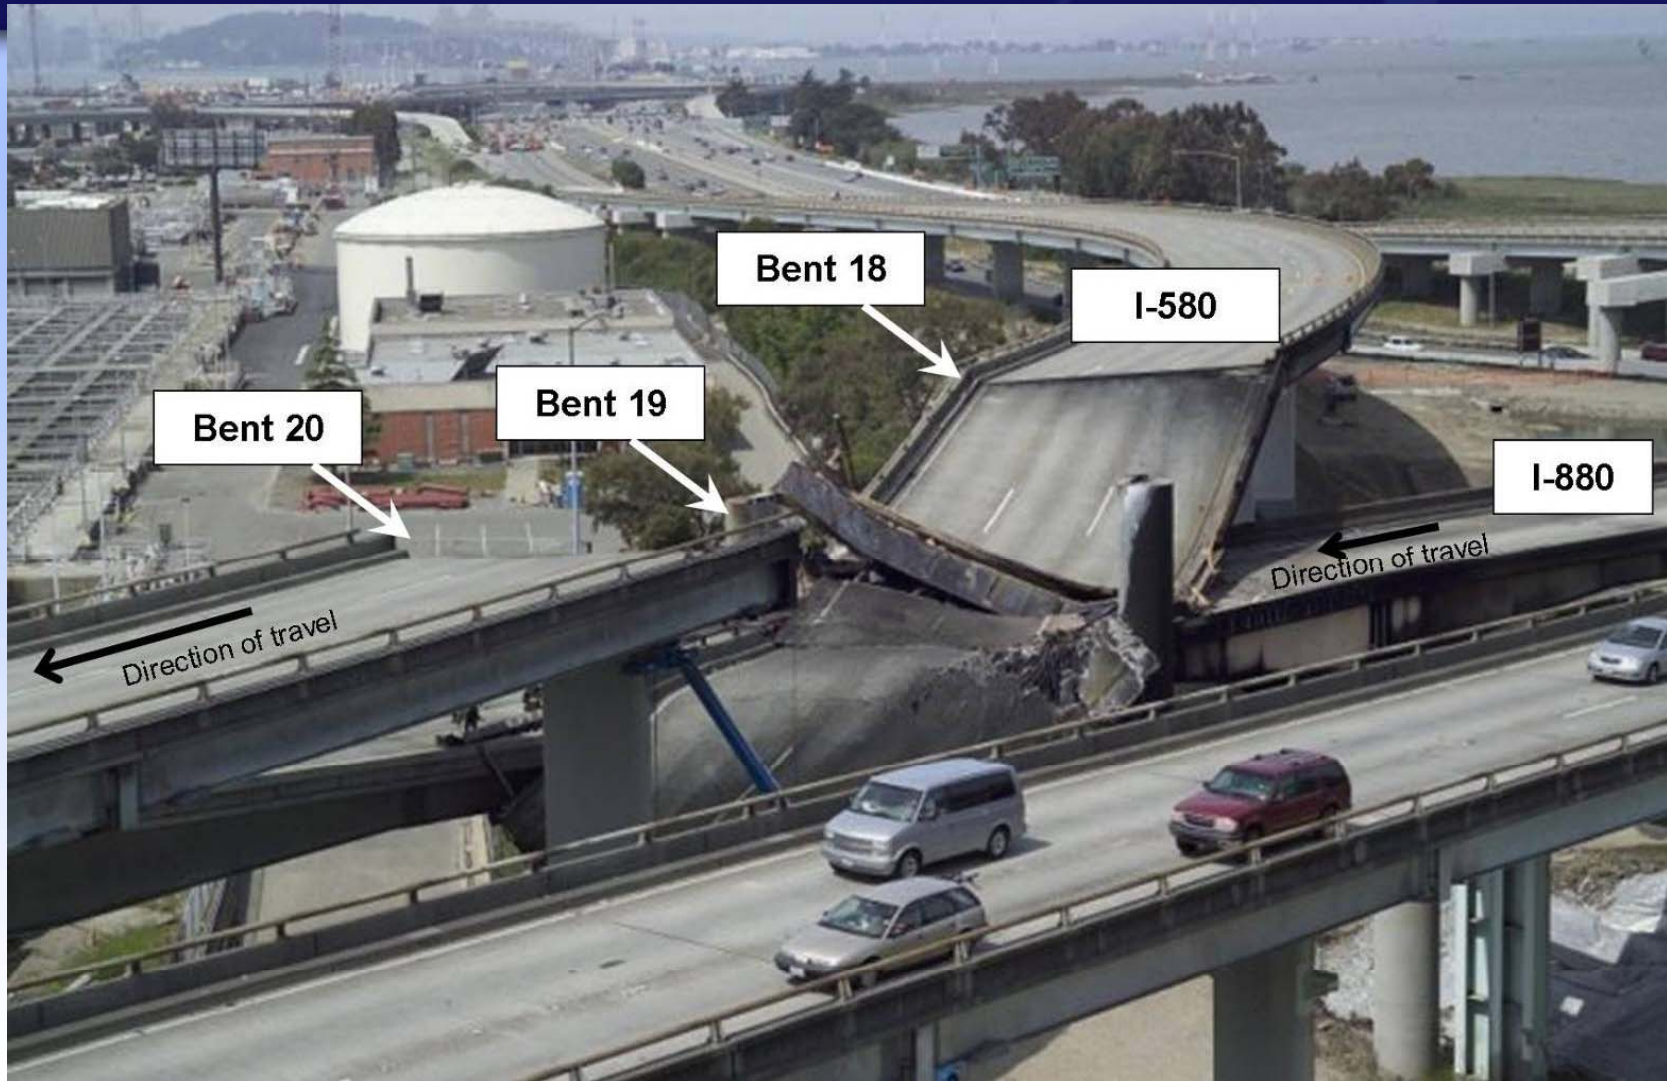
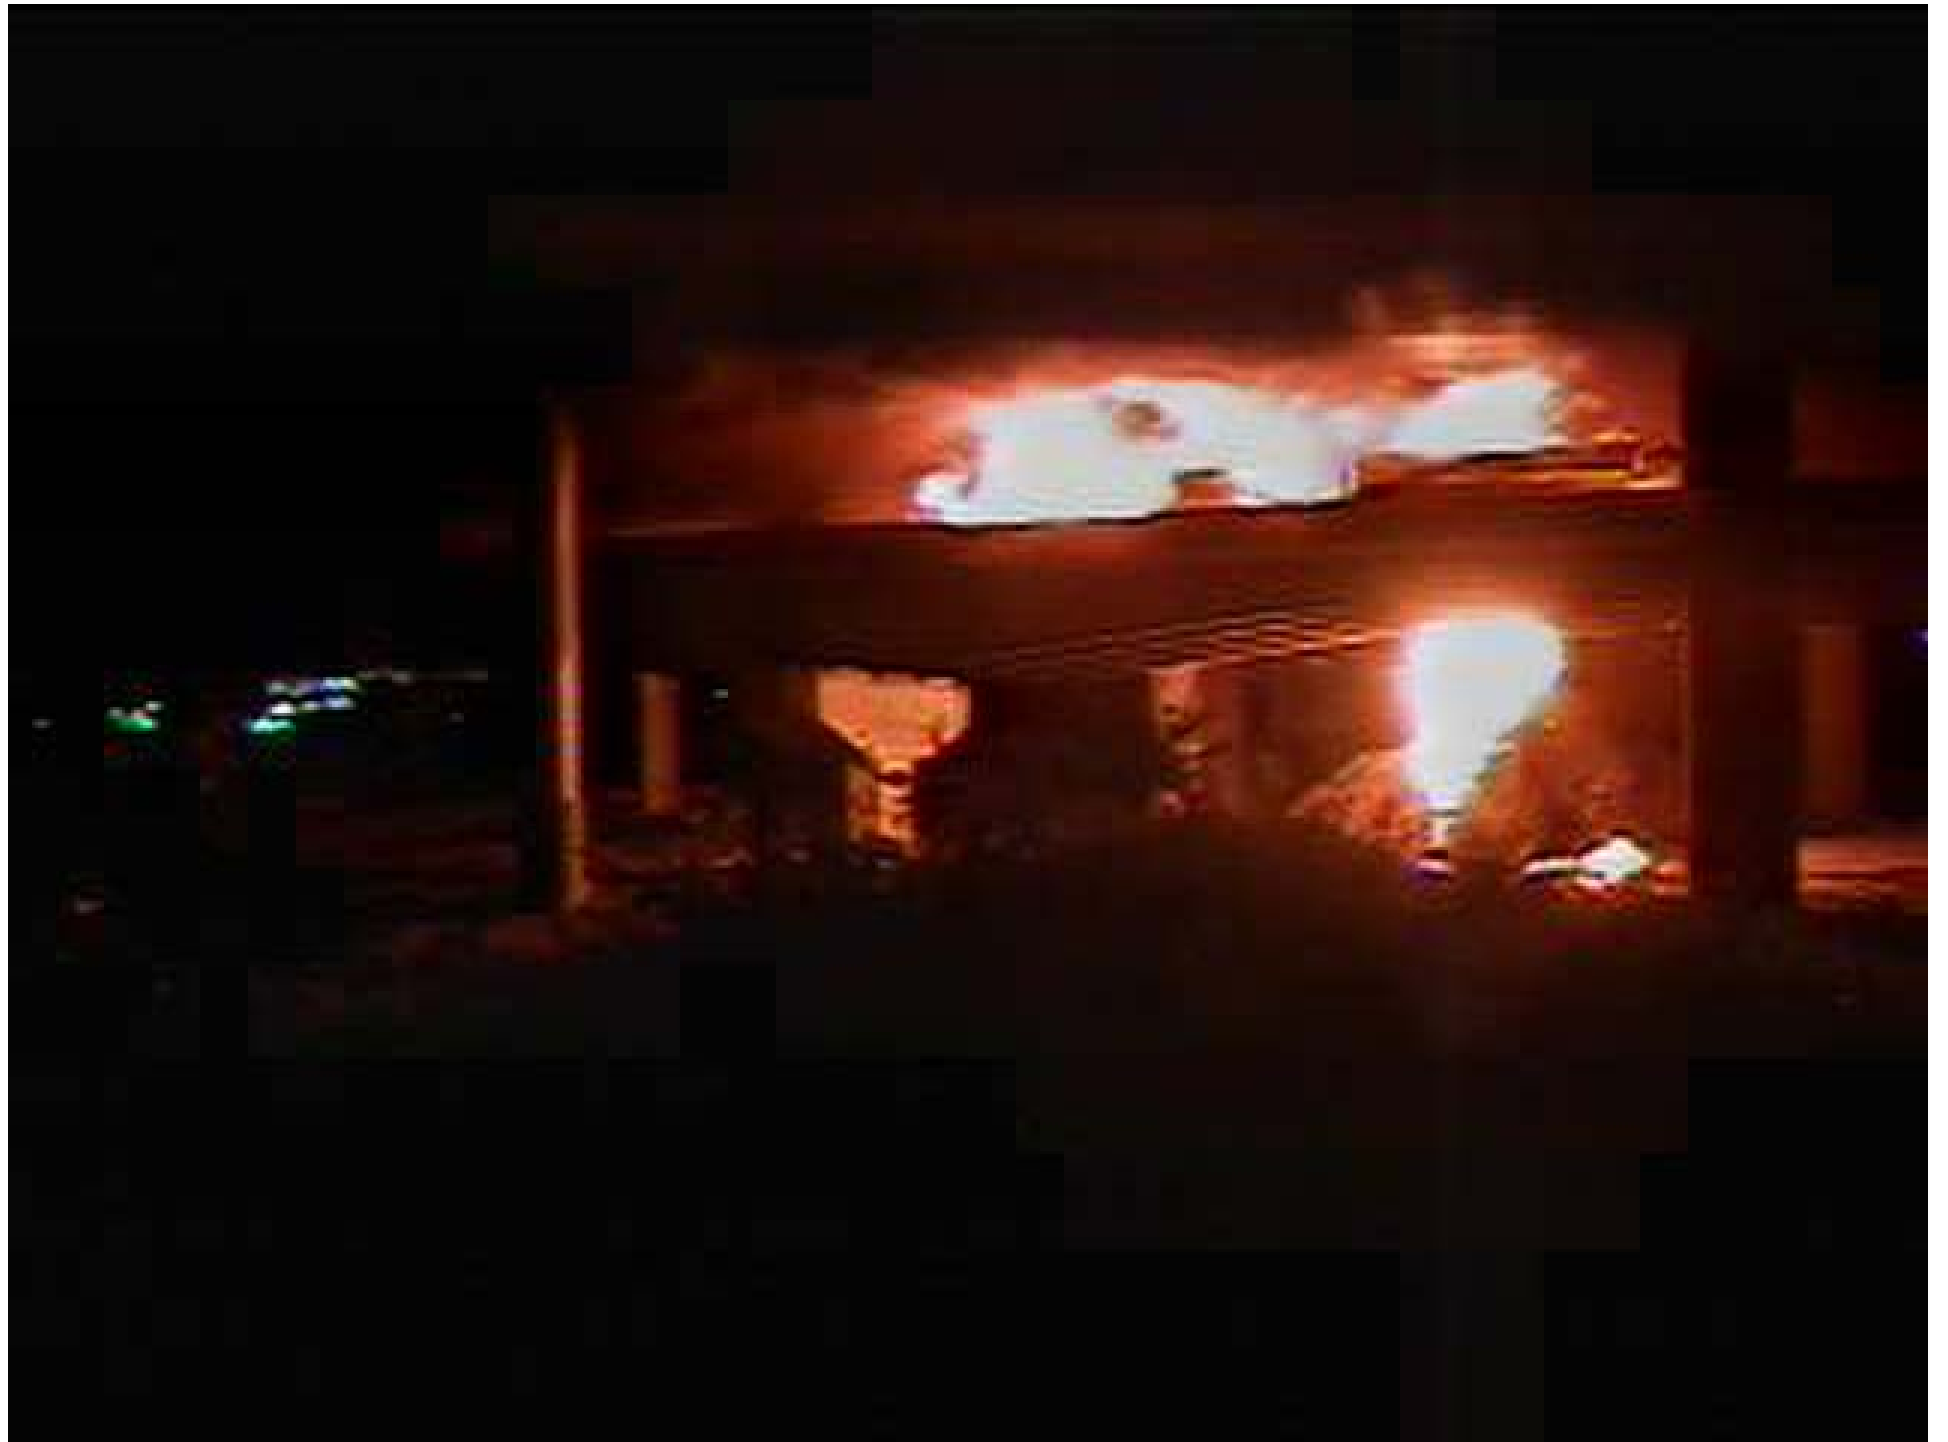
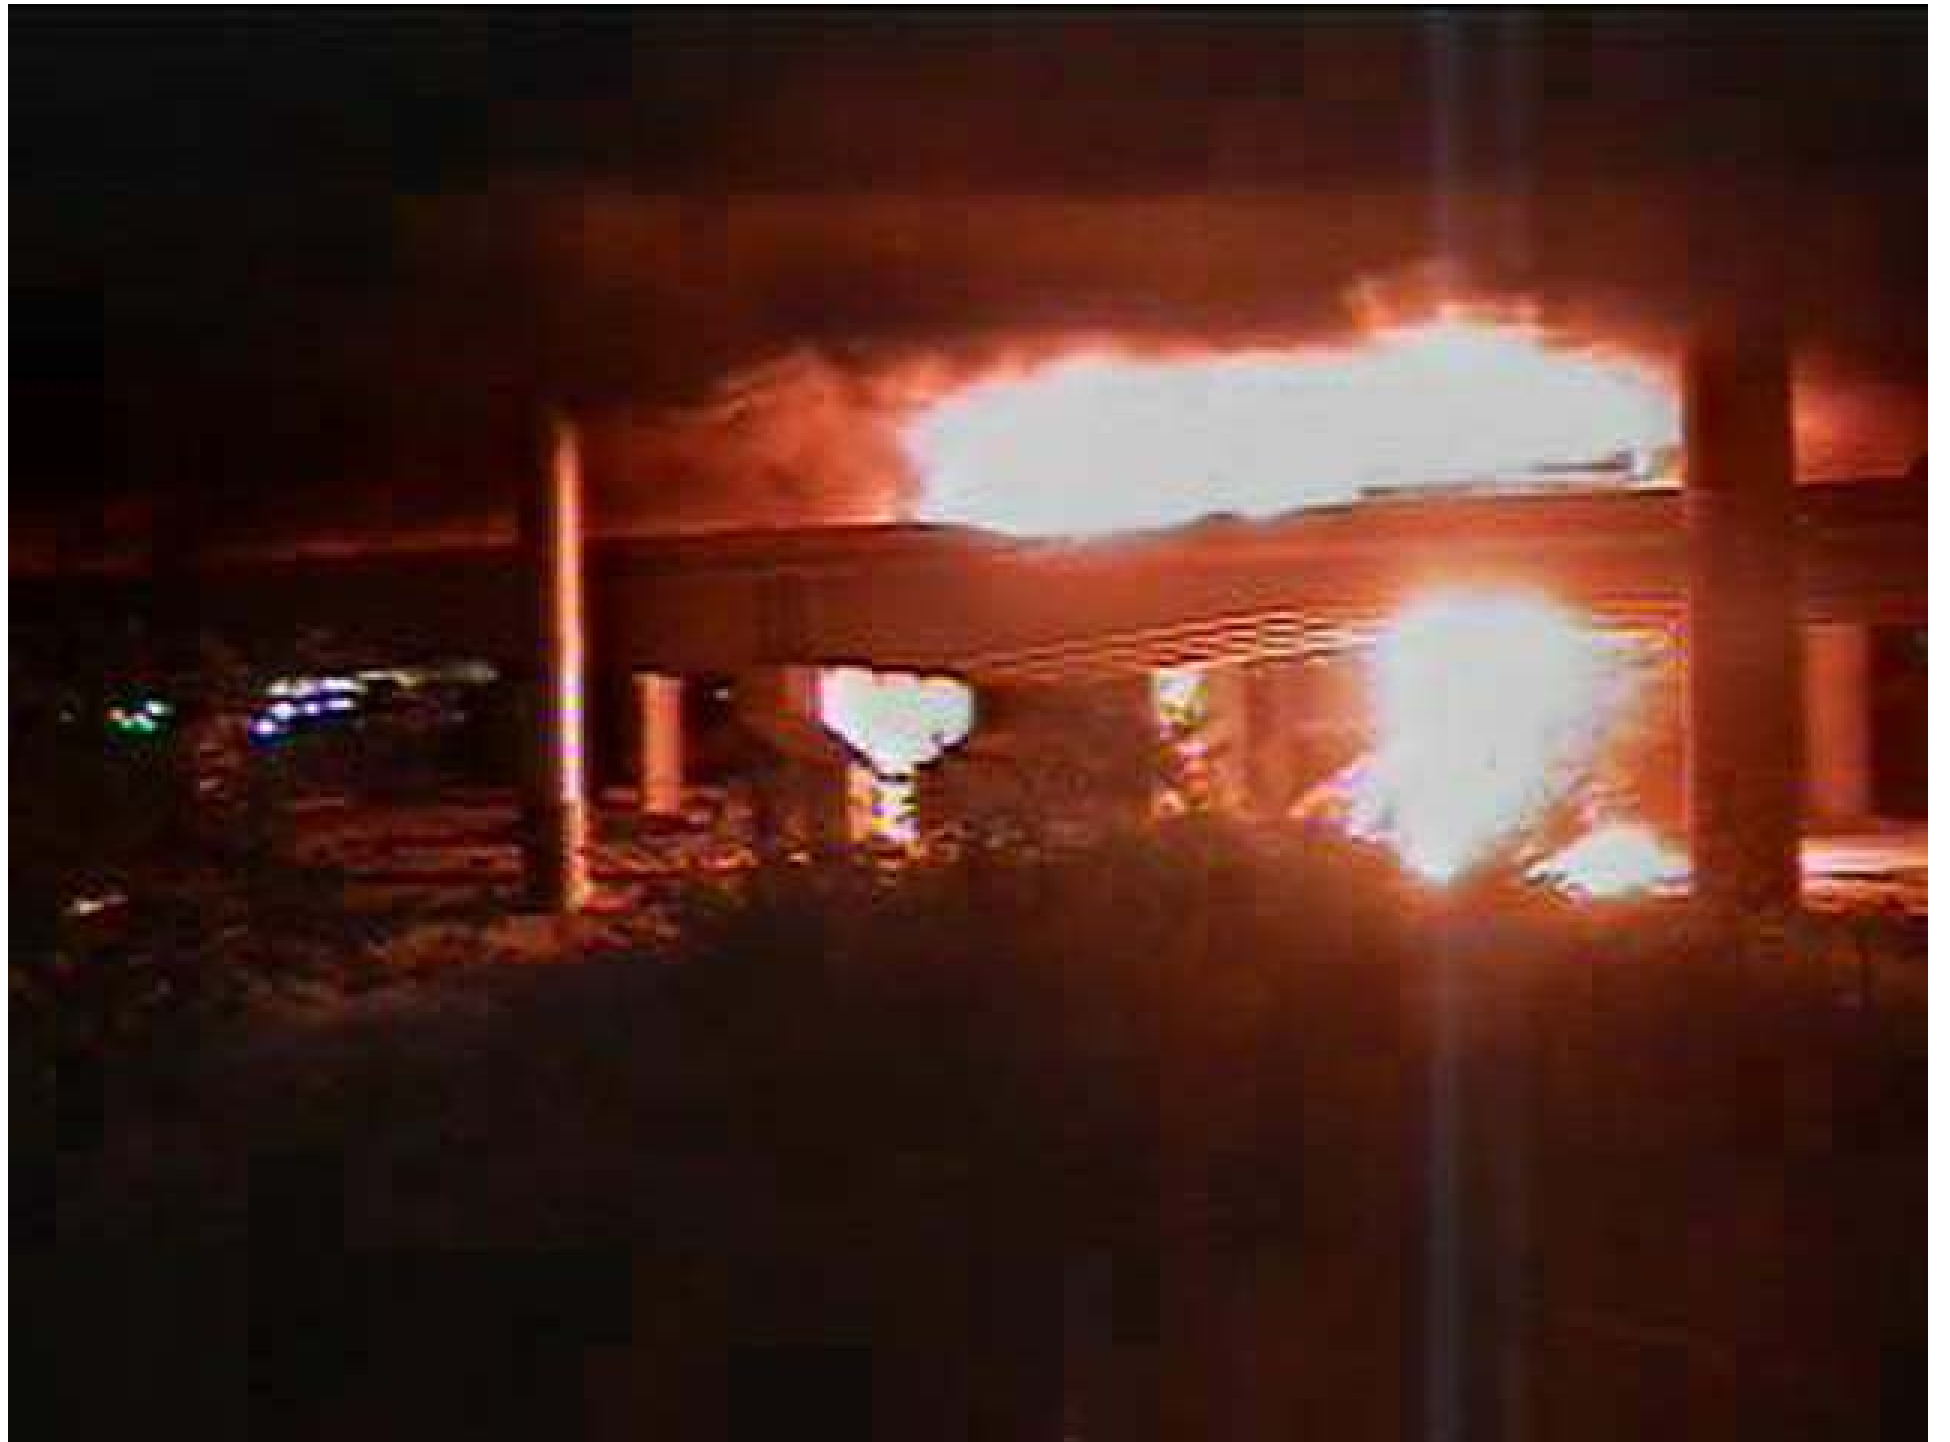
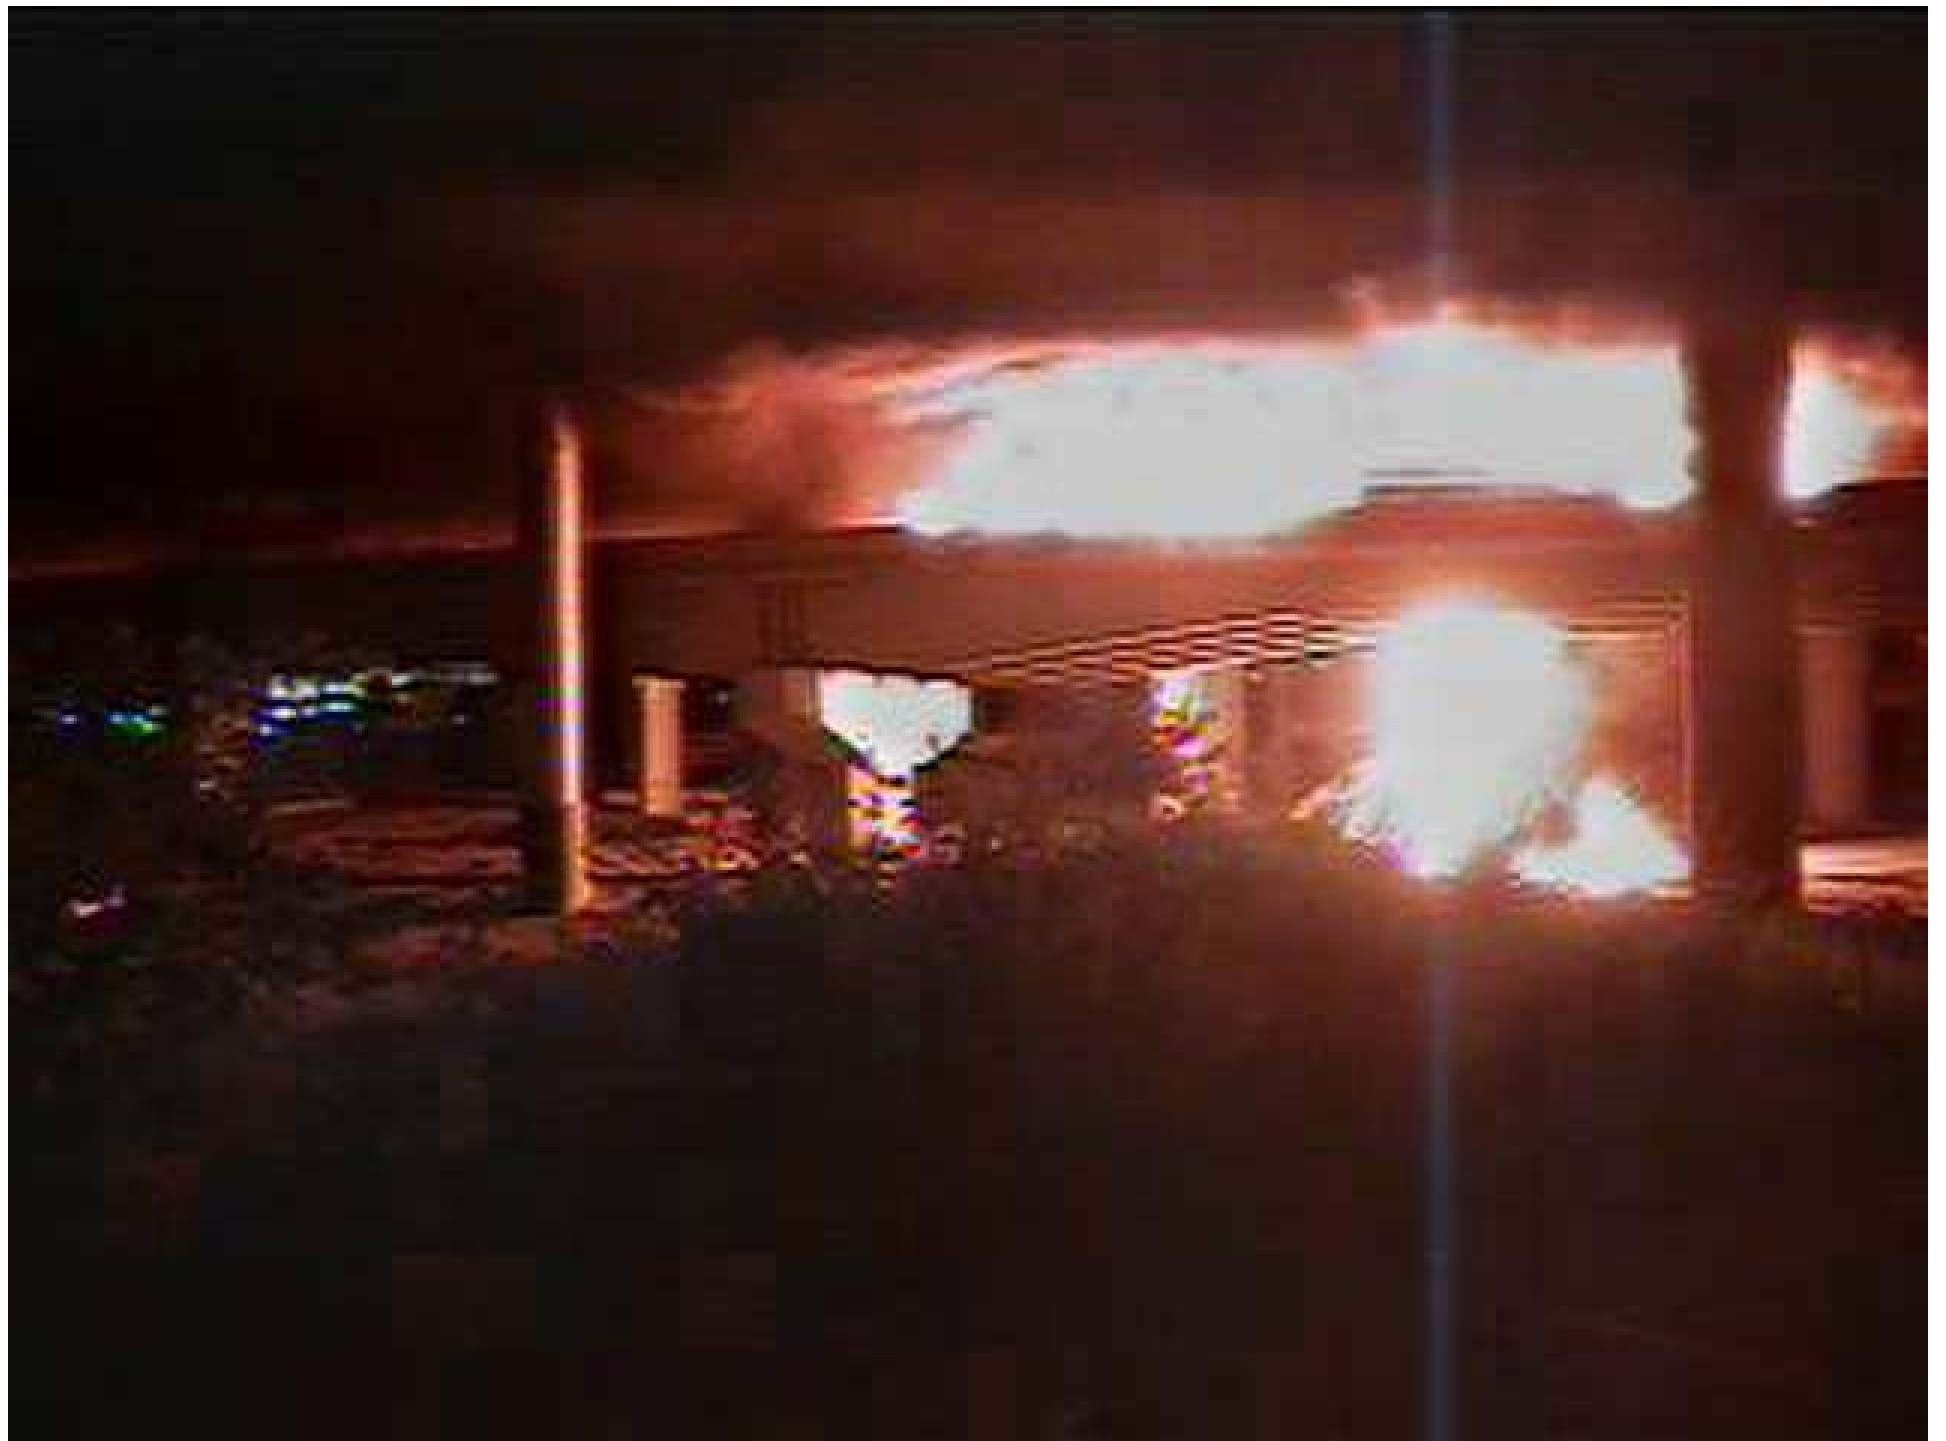
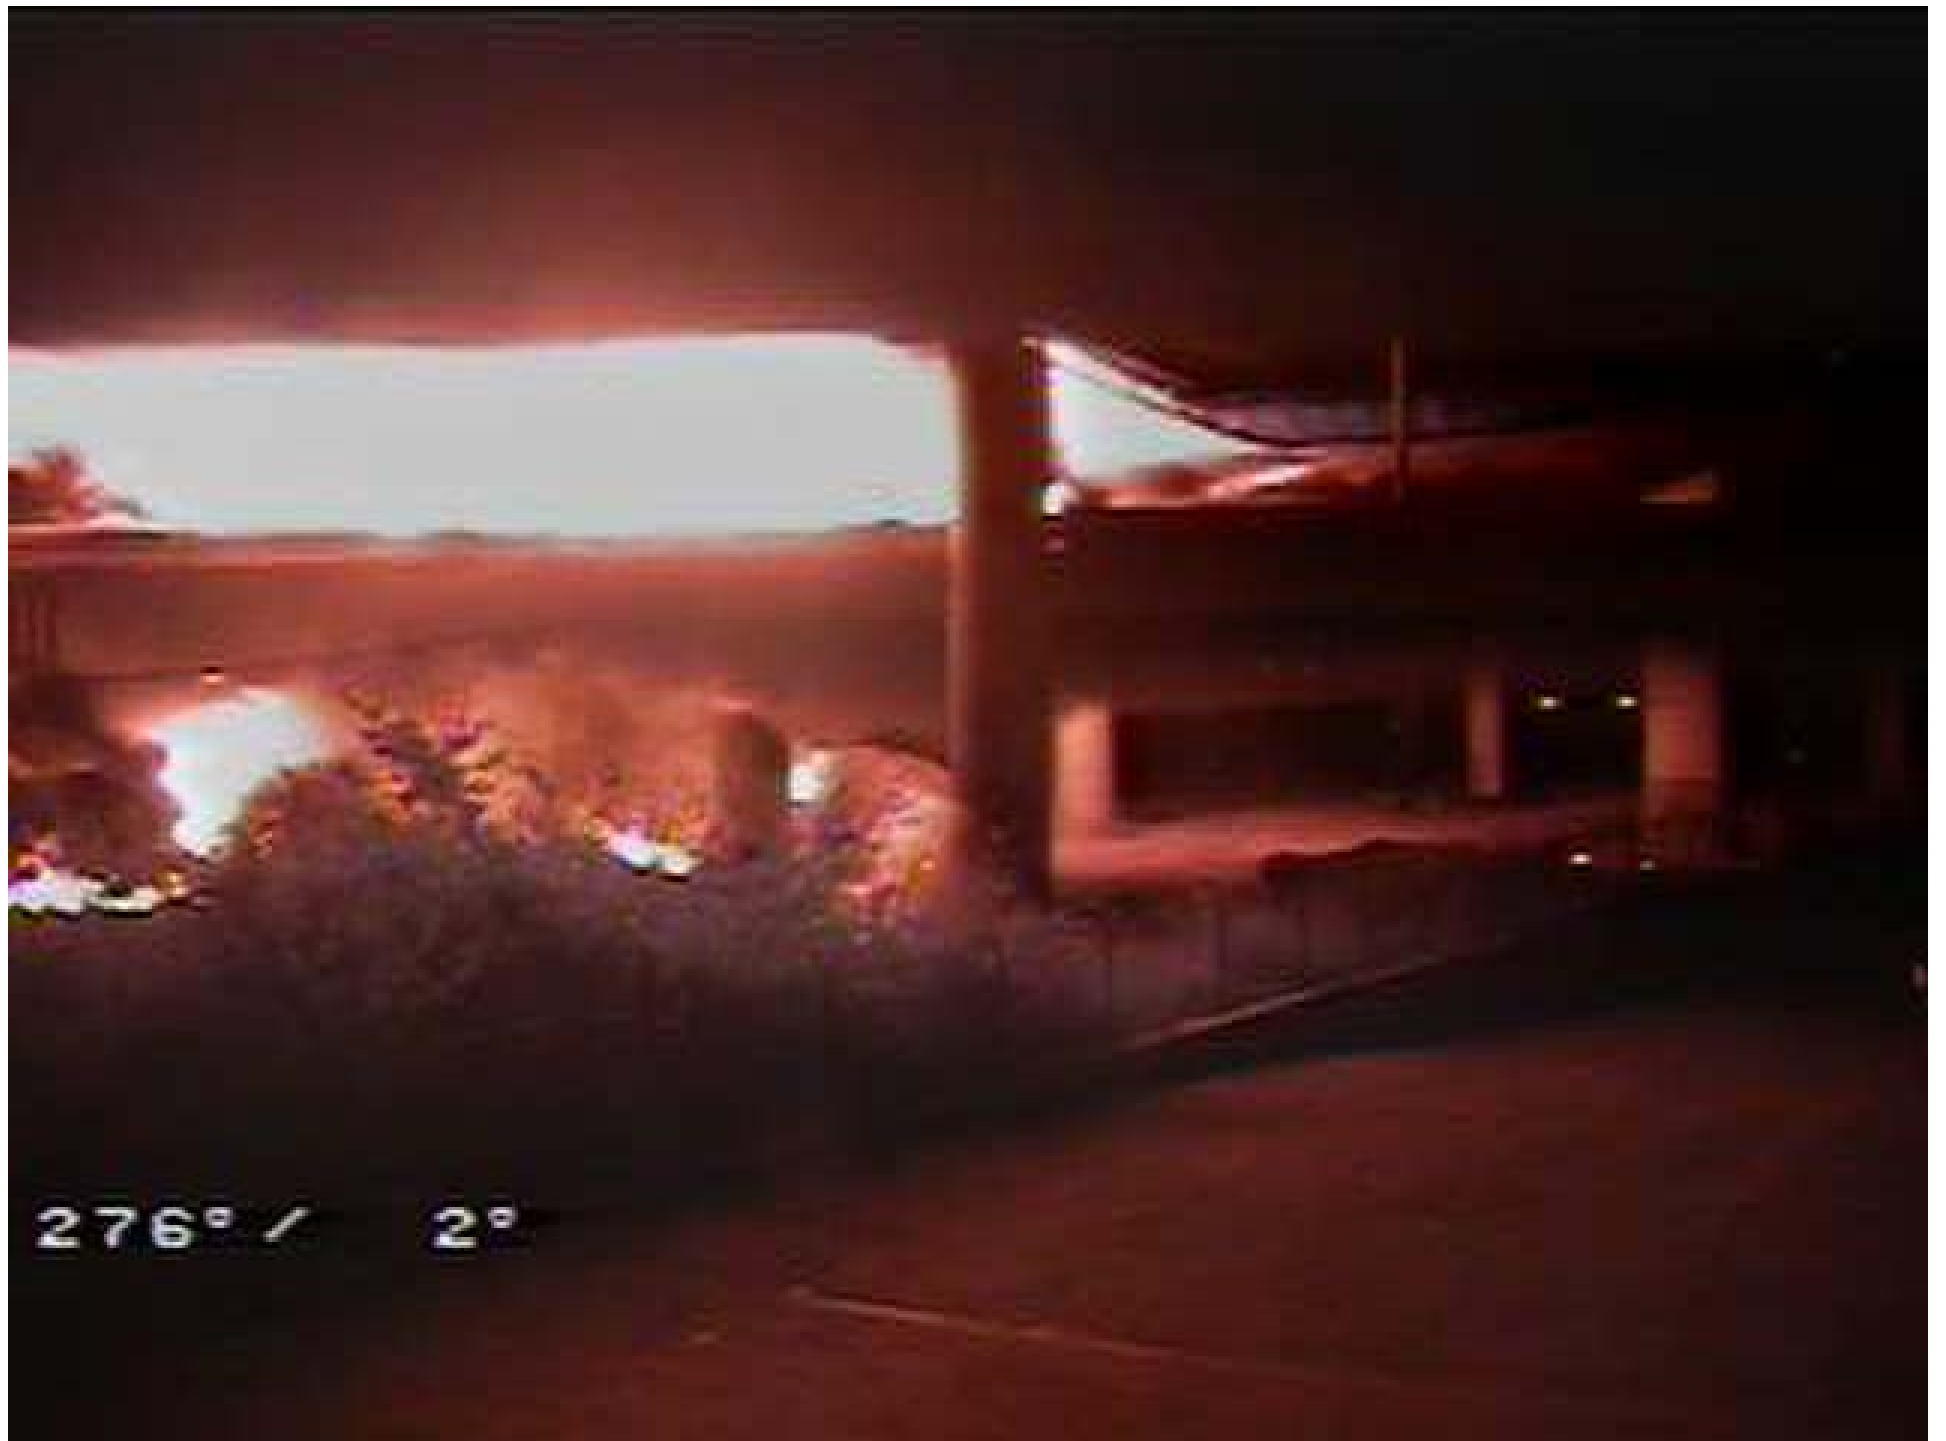
Fire Damage

- **Accident and fire occurred April 29, 2007 at about 3:45 AM**
- **Gasoline double tanker truck**
 - 32,500 liters [8,600 gallons] of gasoline
- **Traveling south along Interstate 880 in Oakland, California**
- **Accident occurred in the MacArthur Maze, an interchange connecting I-80, I-580, and I-880**
- **The I-580 overpass directly above I-880 collapsed approximately 17 minutes after the fire started**

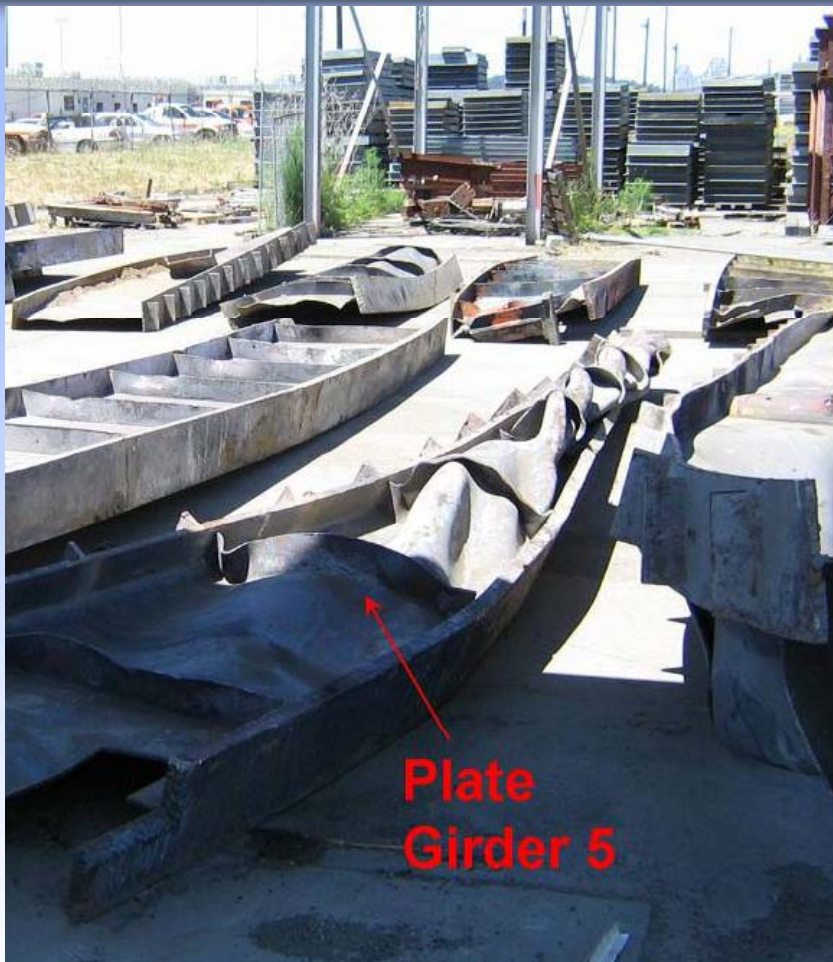
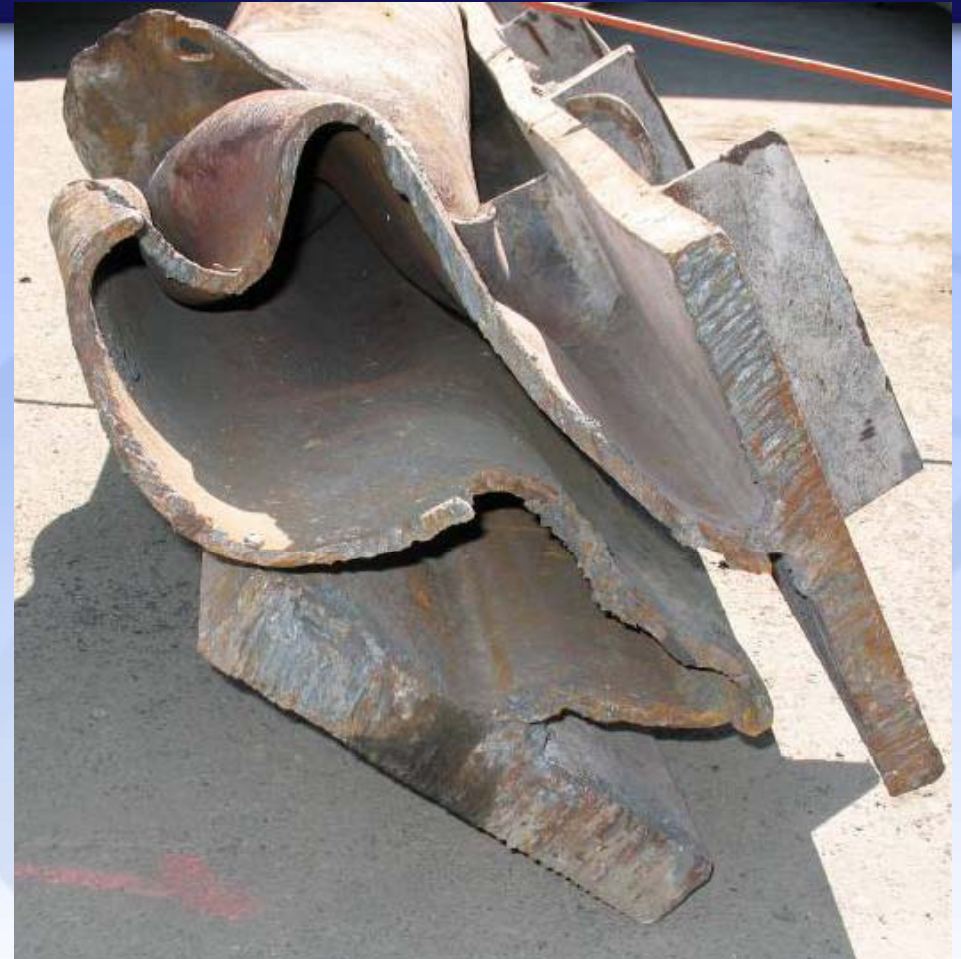
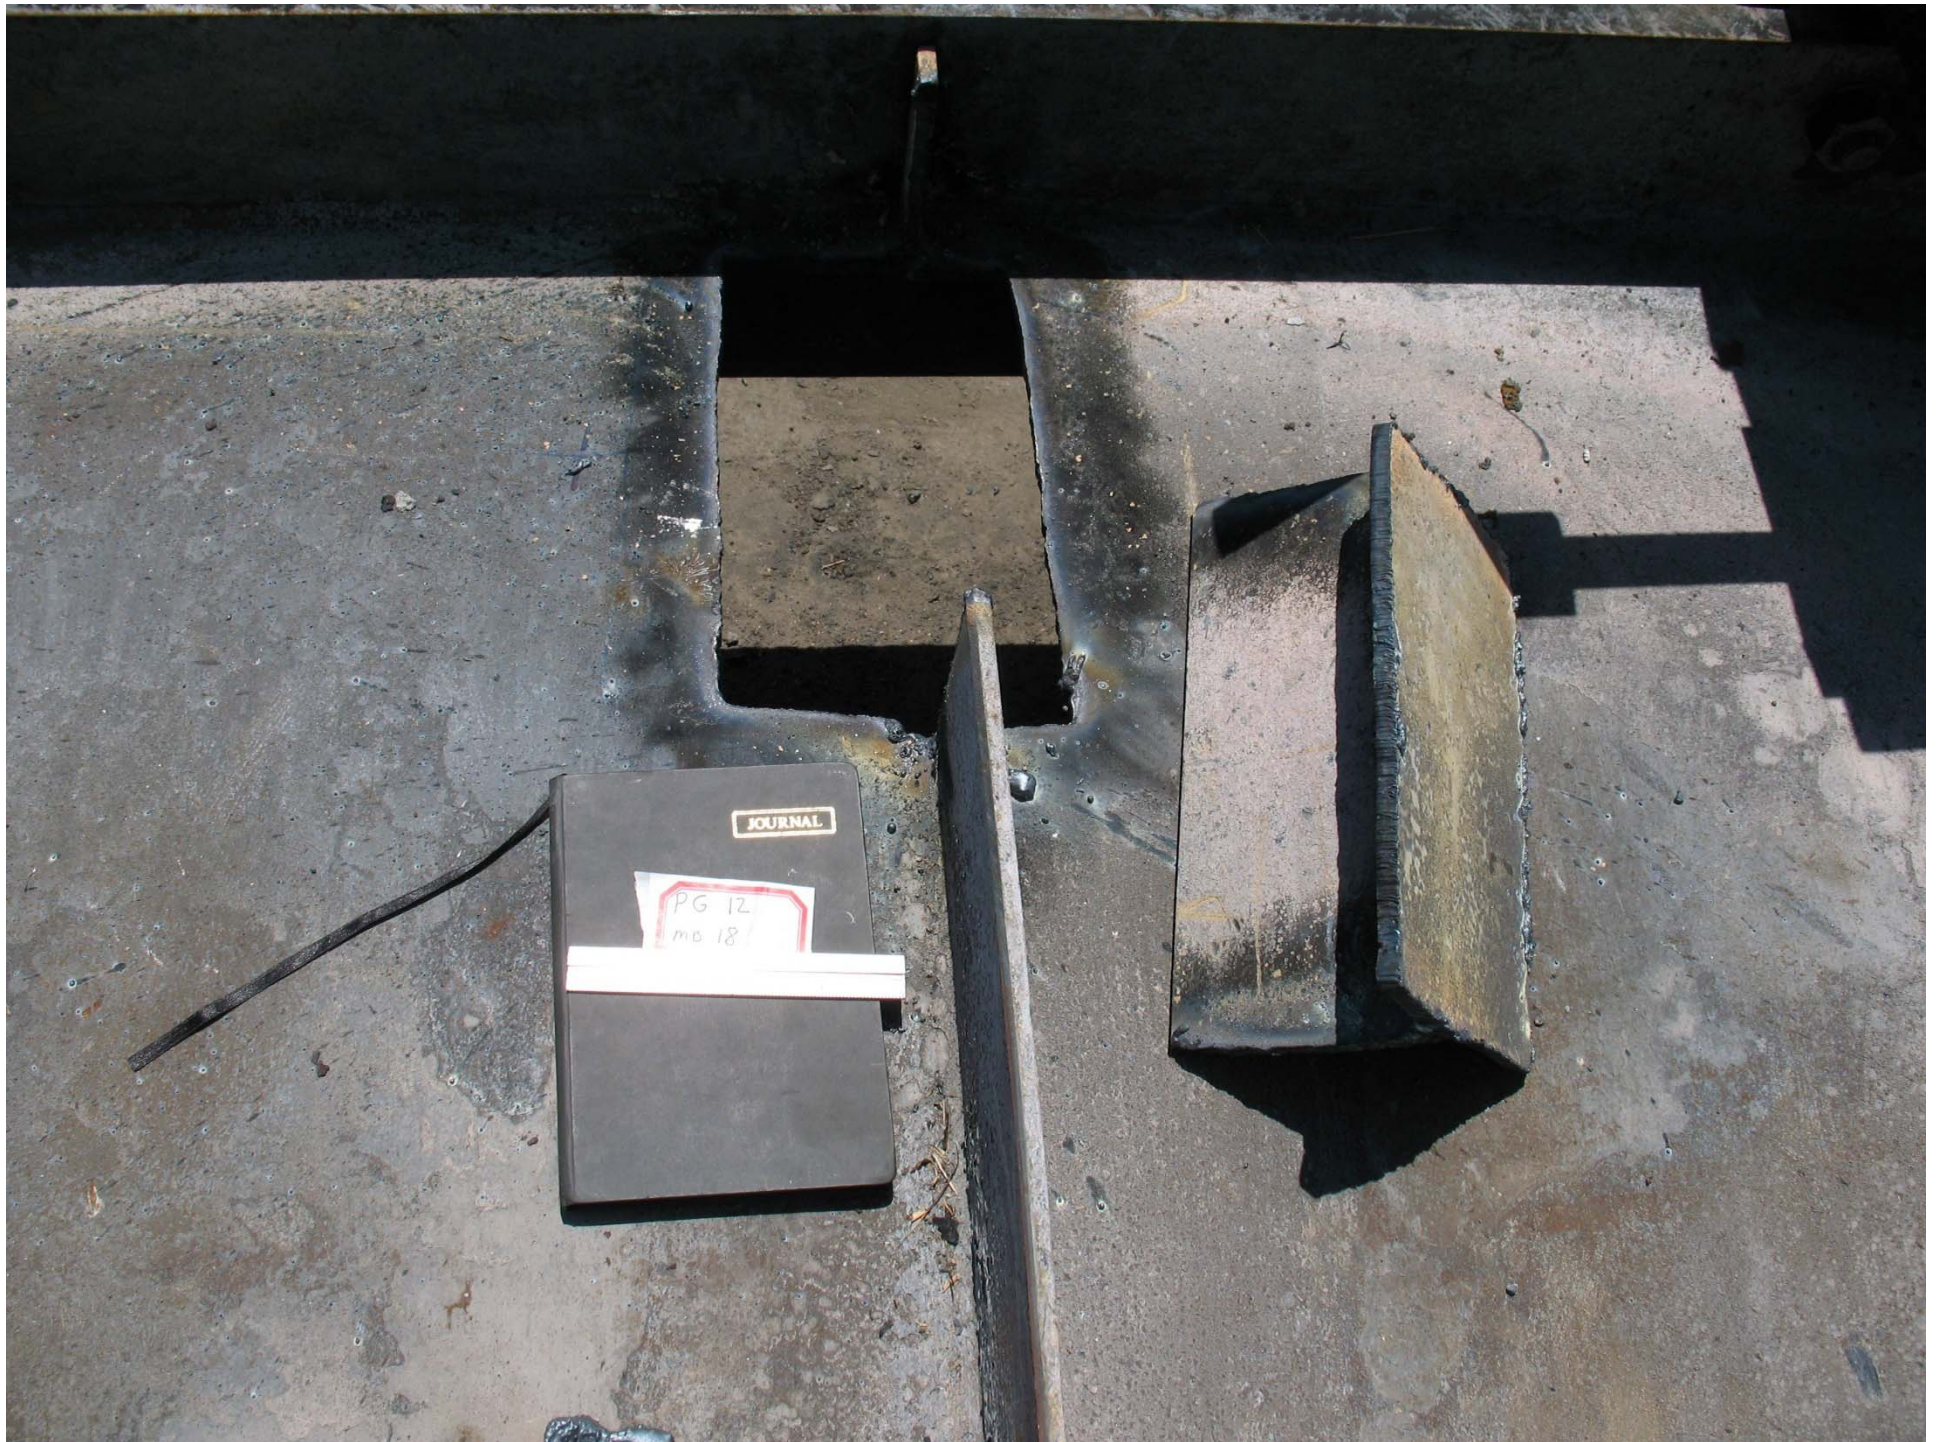
Fire Damaged Girders

- Based on the samples collected and the results of thermal exposures, the temperature of the I-580 overpass is estimated to range from 850° C [1,562° F] to approximately 1,000° C [1,832° F].
- Near the truck, the maximum exposure temperature is estimated to be at least 720° C [1,328° F] and less than 930° C [1,706° F].
- The hottest gas temperatures during the fire were located above the I-880 roadway near the steel girders of the I-580 overpass.

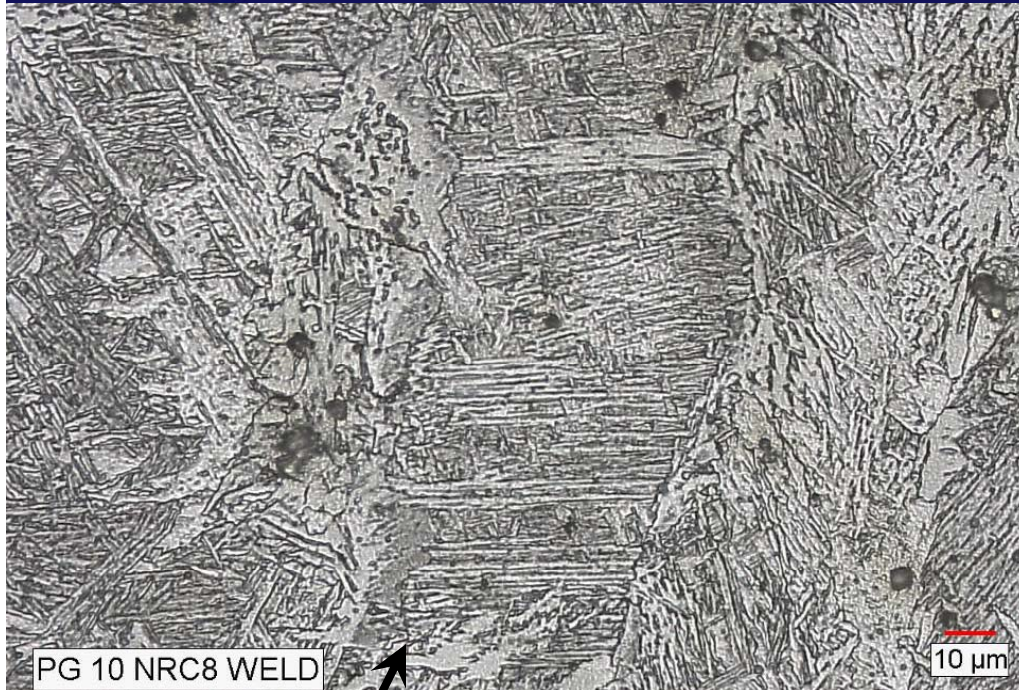
PG 10 NRC8 WELD

As deposited weld metal – dendritic and equiaxed ferrite with some carbides

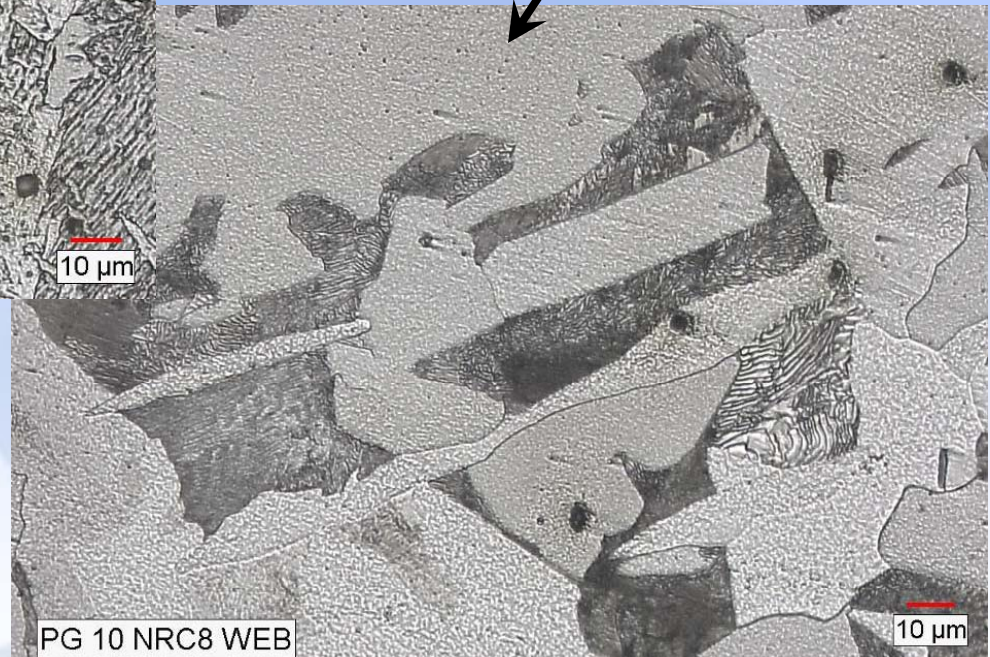
PG 10 NRC8 WEB

Equilibrium microstructure – ferrite (light gray) and pearlite (dark gray)

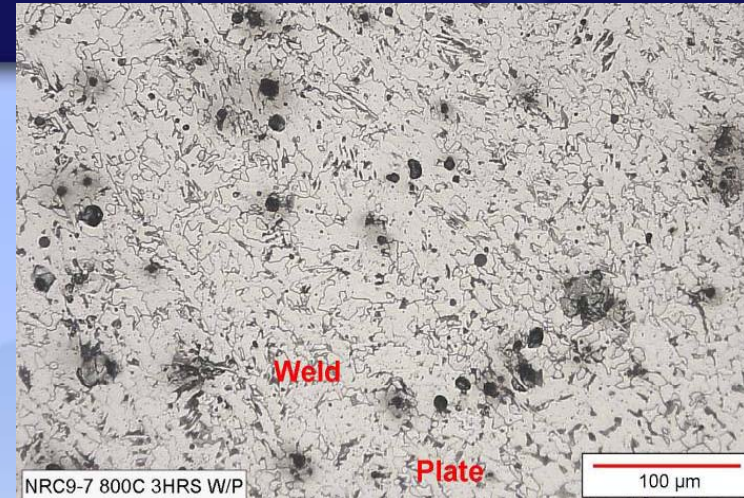
800° C – 3hrs

<i>Sample Number</i>	<i>Thermal Exposure Temperature</i>	<i>Microstructure</i>
NRC 9-1	None	Dendritic Ferrite (as-deposited weld metal)
NRC 9-2	550° C [1,022° F]	Dendritic Ferrite (as-deposited weld metal)
NRC 9-3	600° C [1,112° F]	Dendritic Ferrite (as-deposited weld metal)
NRC 9-4	650° C [1,202° F]	Dendritic Ferrite (as-deposited weld metal)
NRC 9-5	700° C [1,292° F]	Dendritic Ferrite (as-deposited weld metal)
NRC 9-6	750° C [1,382° F]	Dendritic Ferrite (as-deposited weld metal)
NRC 9-7	800° C [1,472° F]	Dendritic Ferrite with small regions of pearlite
NRC 9-8	850° C [1,562° F]	Ferrite and Pearlite with some dendritic Microstructure
NRC 9-9	900° C [1,652° F]	Ferrite and Pearlite (complete transformation)

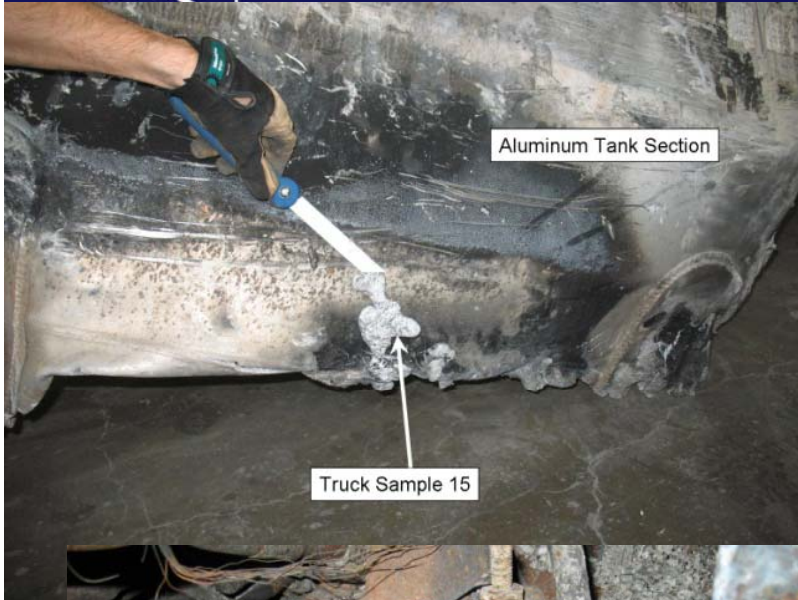
Truck Sample 15

Aluminum Tank Section

- **Aluminum Alloys (Partial Melting)**
 - Tank sections, wheel rim, radiator screen
 - Analyzed to determine composition and melting points
- **Copper Alloys (No Melting)**
 - electrical wiring, battery cables
 - Analyzed to determine composition
- **Iron Based Alloys (No Melting)**
 - Vehicle frame, stainless steel brackets, bolts
 - Frame exhibited scaling
 - Rearview mirror bracket was not sensitized
 - Fasteners tested for yield and tensile strength

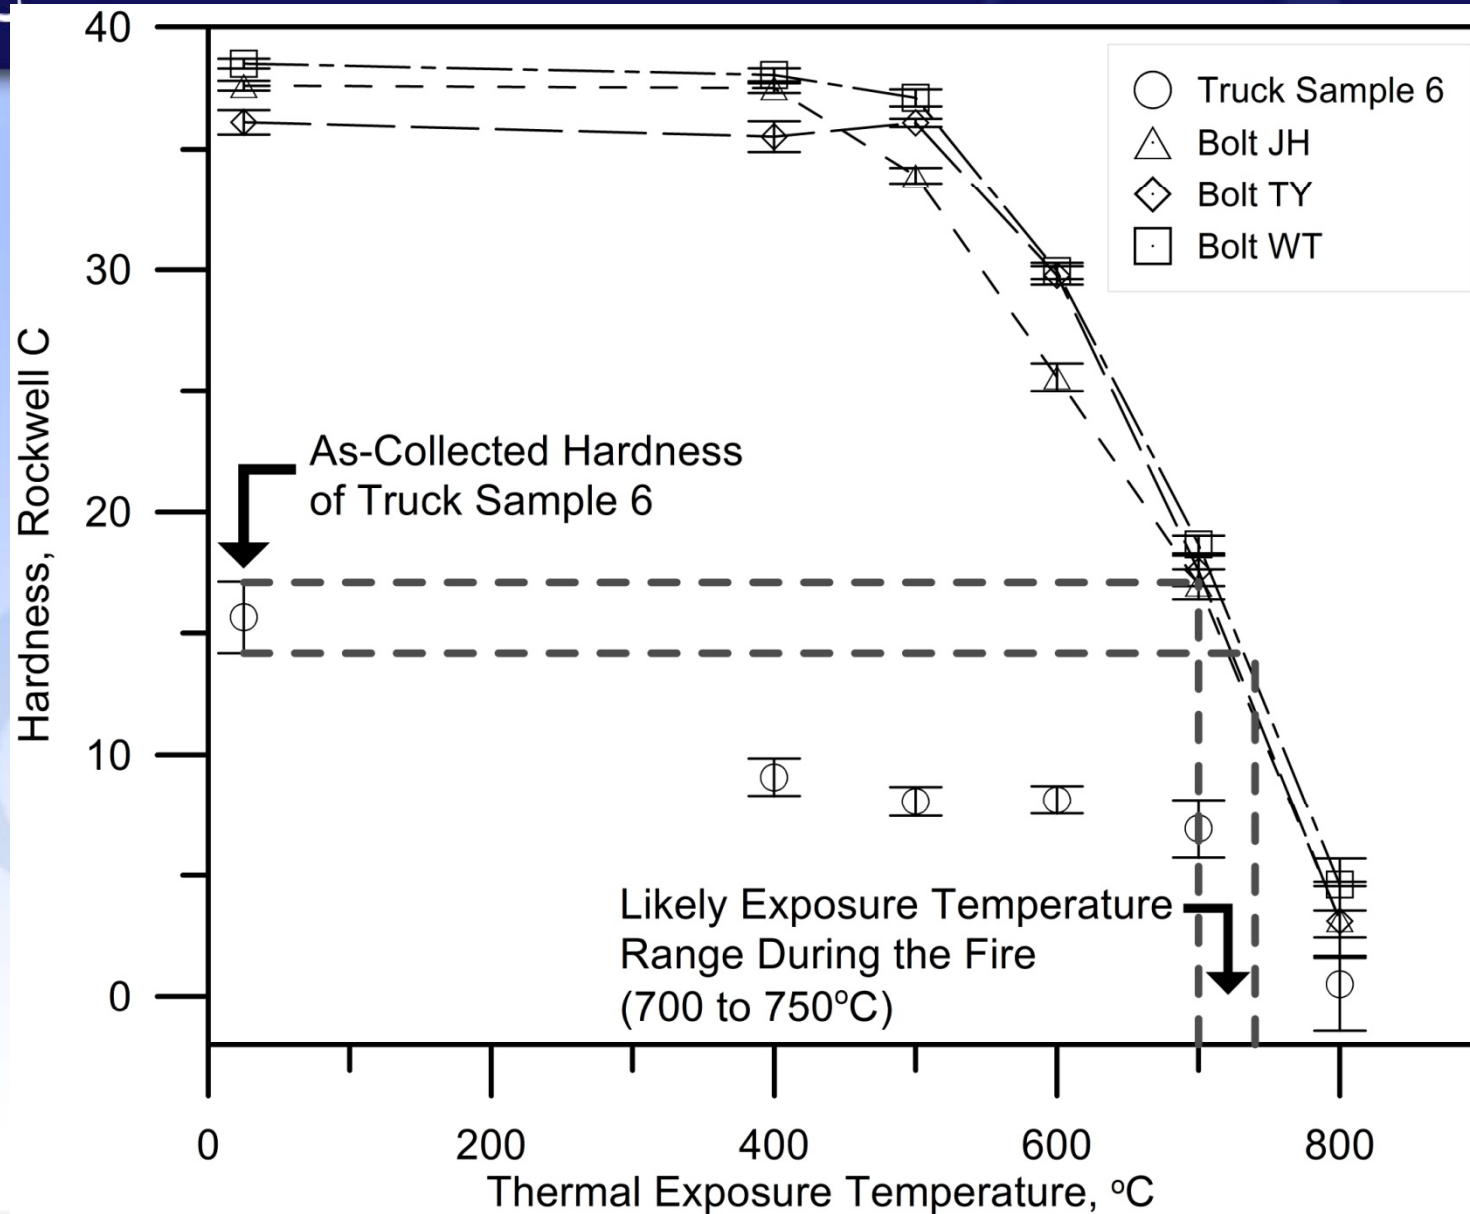
Exposure Temperature vs. Hardness

- **Grade 8 Hardware (new)**
 - Minimum 130,000 psi yield
 - Minimum 150,000 psi tensile
 - Rockwell hardness C33 to C39
- **Truck Sample 6 (as exposed)**
 - 98,000 psi tensile
 - Rockwell C16
- **Testing indicated a exposure of 700 to 750° C**
