MacArthur Maze and Newhall Pass Fires and their Implications for Spent Fuel Transport

Christopher S. Bajwa, Earl P. Easton
U.S. Nuclear Regulatory Commission,
Washington, DC

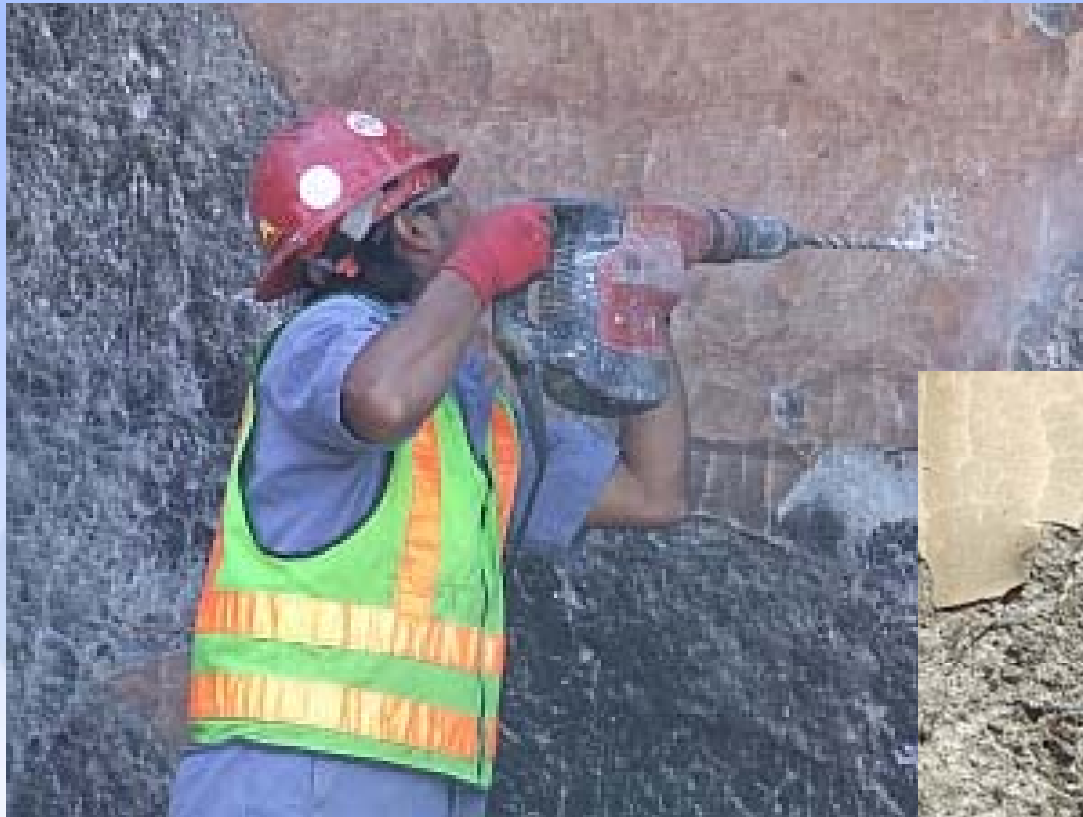
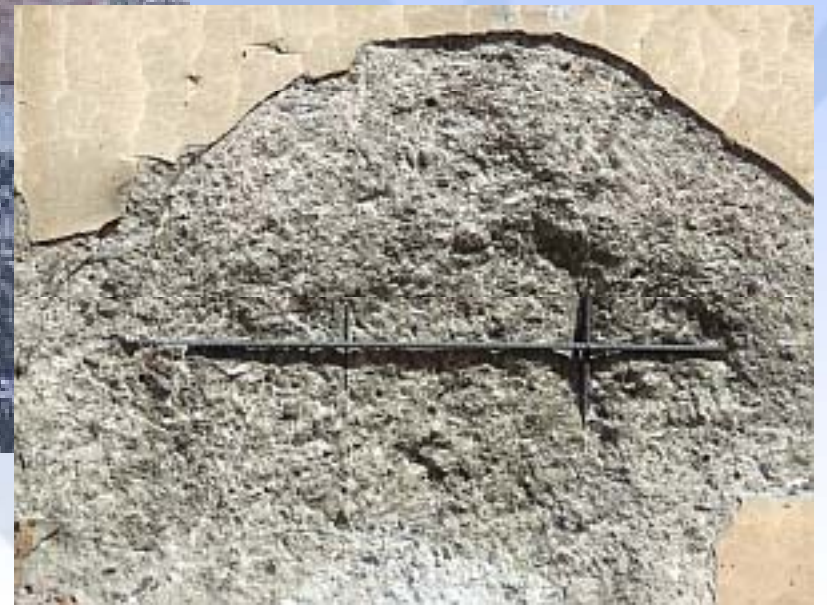
NHP Tunnel: Post-Fire Damage

- **Temperature in the tunnel reached levels high enough to melt aluminum.**
 - greater than 560° C [1,040°F]
- **At the location of truck 17, a higher temperature was observed based on a melting point analysis.**
 - greater than 884° C [1,623°F]
- **Hardness data (from bolts) indicated temperatures between 400 and 800 °C [750 and 1,470 °F].**
- **Based materials analyses results, gas temperature varied with time and location and exceeded 884° C [1,623°F] in at least one location.**

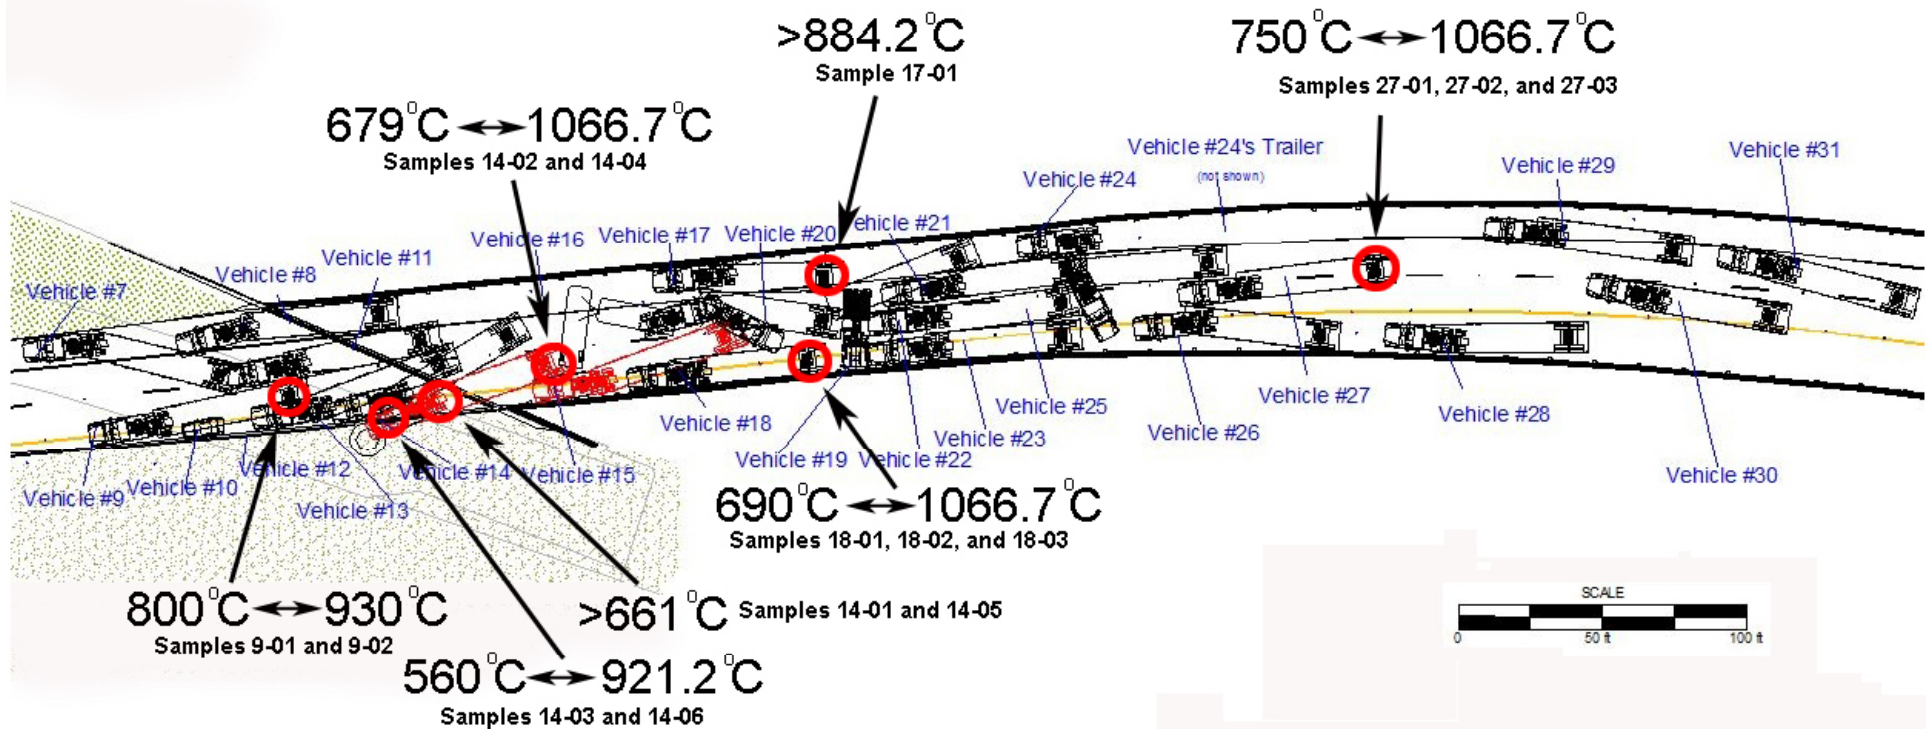
Sample Locations in Tunnel

Vehicle Number	Component/Sample	Condition/ Analysis	Temperature Bound	Temperature Range
9	Graded Bolts	hardness and microstructure	lower	880-930 °C [1,472-1,706 °F]
	Brass Schrader Valve	unmelted	upper	
	Aluminum	melted	lower	
14	Aluminum from Grill of Tractor	melted	lower	560 – 920 °C [1,040-1,690 °F]
	Brass Clamp from Engine Compartment	unmelted	upper	
	Aluminum Flooring (Trailer Front End)	melted	lower	> 660°C [>1,220°F]
	Aluminum Wheels (End of Trailer)	melted	lower	680-1,070 °C [1,256-1,958 °F]
	Copper Wiring (End of Trailer)	unmelted	upper	
17	Brass Compression Fitting Ferrule	melted	lower	> 880 °C [>1,616 °F]
18	Aluminum (at Wheel Level)	melted	lower	690-1,060 °C [1,274-1,940 °F]
	Brass/Copper	unmelted	upper	
27	Graded Bolt	hardness and microstructure	lower	750-1,070 °C [1,382-1,958 °F]
