# FRA's Presentation of Radioactive Rail Car fire in Bedford Park, IL.

# **The Actual NRC Description of the Incident.**

# Investigation Conclusions

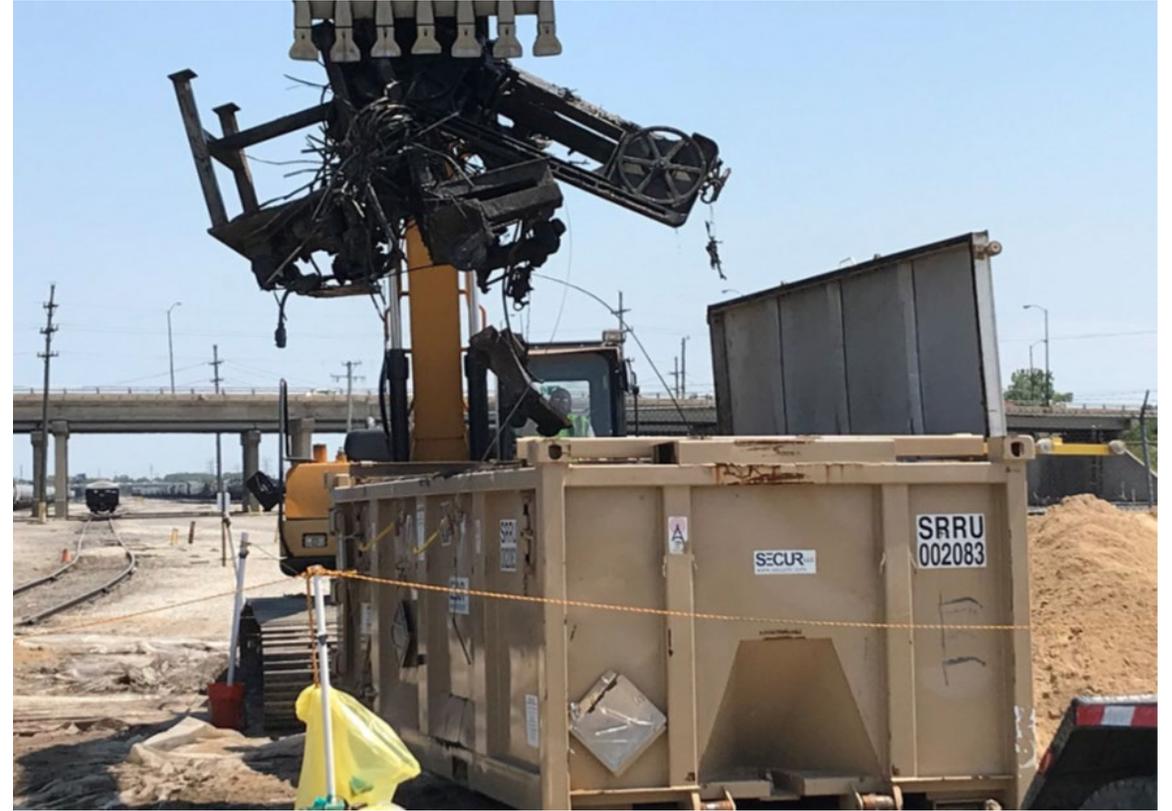
## **FRA Observations during the Transloading Operations**

During the transloading, FRA reported and photographed large metal machinery parts, including metal shop tables, drill presses and other objects as they were removed from the car. Large pieces of wood and the remains of other combustible debris were also removed along with the Zirc Rods.

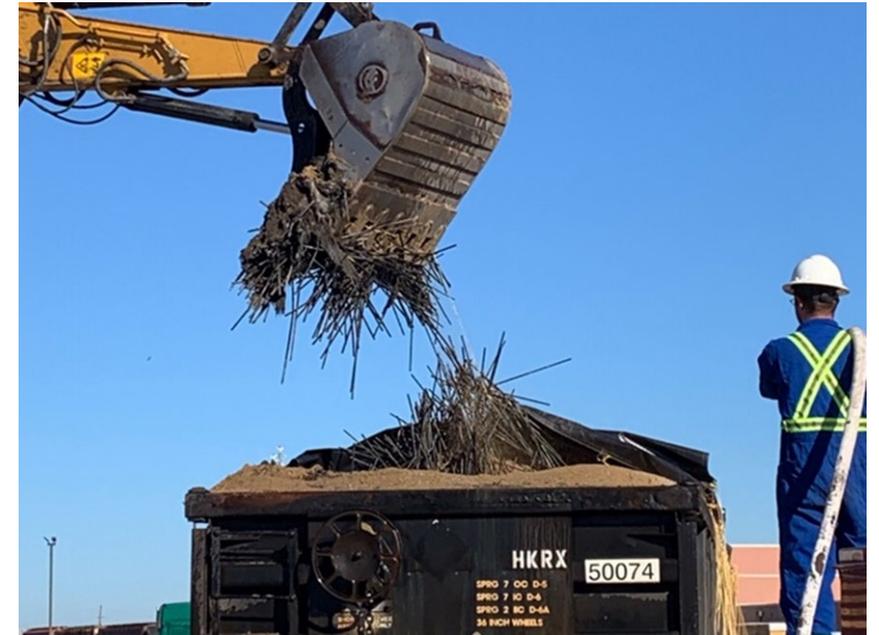
## **Additional FRA Observations during the Transloading Operations**

The Zirc Rods were dispersed throughout the gondola in no certain arrangement and were observed and photographed of various lengths. Some of the Zirc Rods were banded tighter and other looked to be used, flattened raggedly cut and ready for disposal. Because of the various degrees of the conditions of these rods, the “Zirc Rod,” entry on the shipping paper became a bigger, more intriguing question.

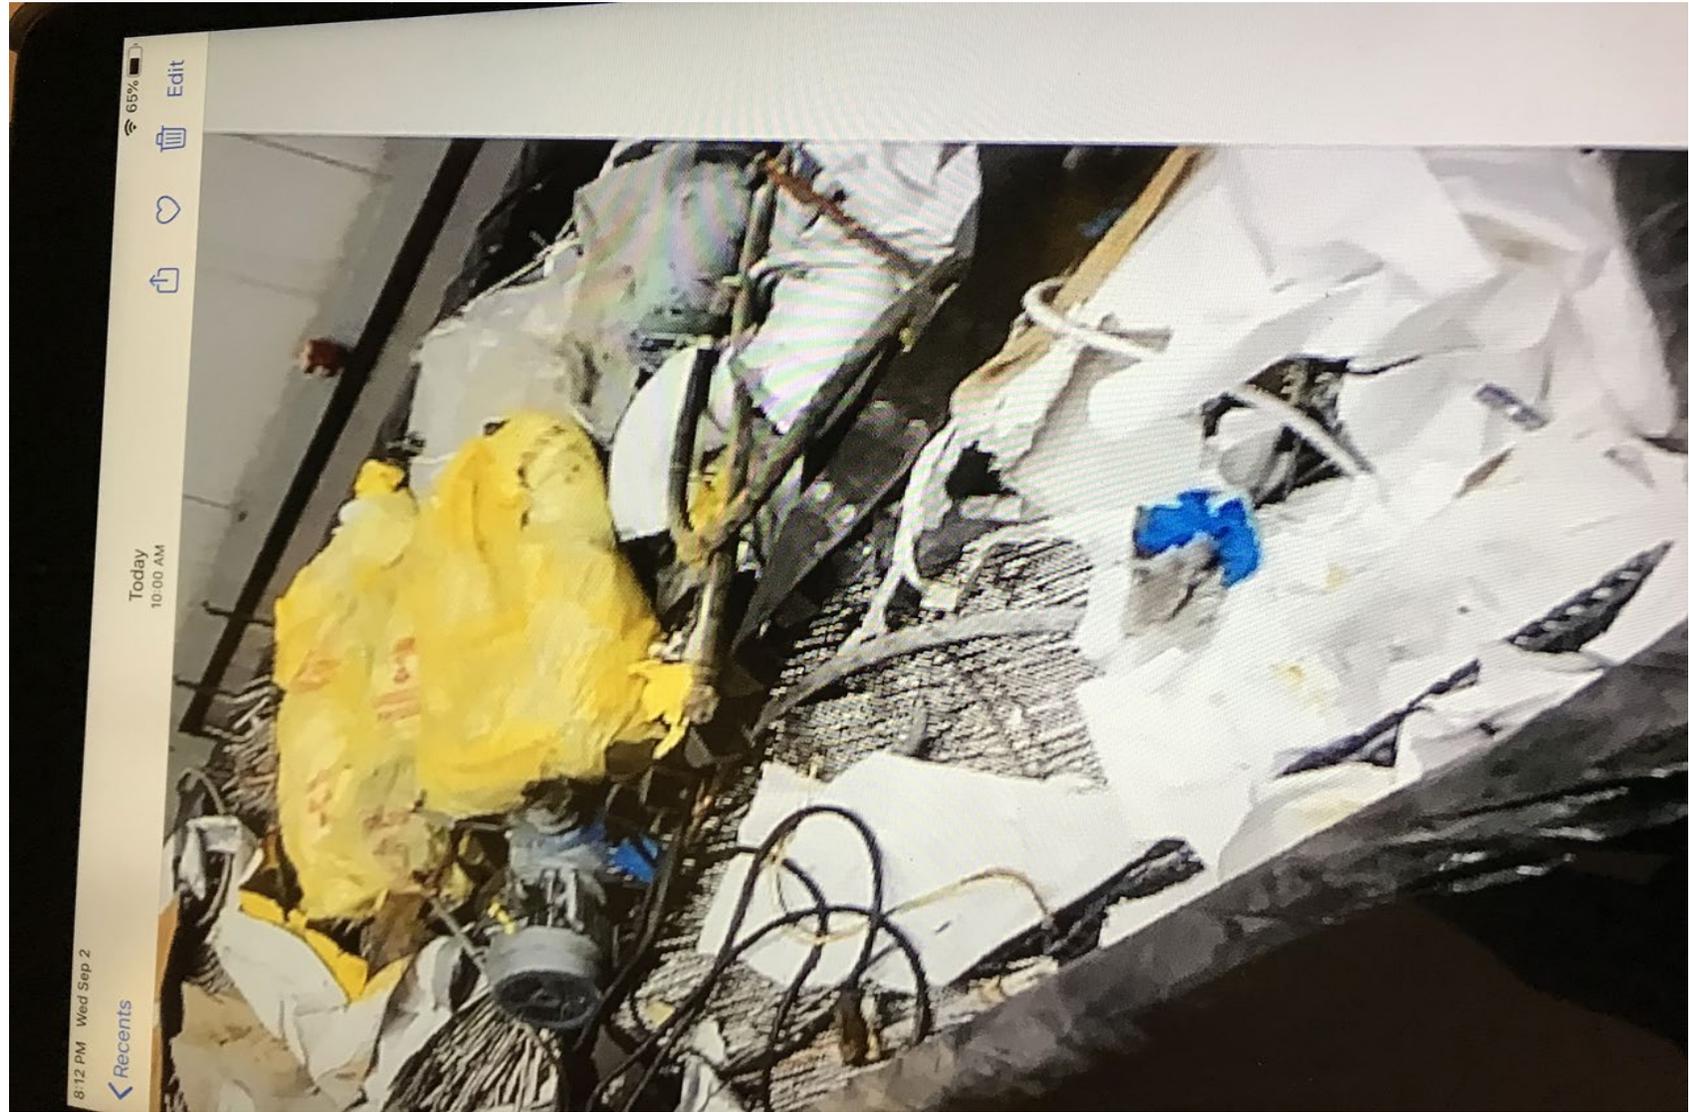
**Photograph  
of the loaded  
car provided  
by the  
shipper  
before the  
fiberglass lid  
was applied**

- That section also indicates not to use water. Water was utilized to extinguish the fire created when the contents of the rail car was unloaded that created an oxygen rich environment.
- There were no special handling instructions provided from the shipper or conveyed on the shipping documents with the shipping of these Zircalloy rods. The Zirc Rods were found piled on top of each other in the car when the transloading/remediation began.

- This investigation also proved that the shipper improperly loaded this car by allowing the Zirconium Rods to interact with other Zirconium Rods and other metal objects, despite information of the SDS for this material.
- This metal-to-metal contact created friction through movement in transportation that caused the rods to create filings. Those filings are the most volatile and they created the sparks that ignited the combustible dunnage that was loaded in the void spaces between the rods and other metal objects in the car.
