MacArthur Maze and Newhall Pass Fires and their Implications for Spent Fuel Transport

Christopher S. Bajwa, Earl P. Easton
U.S. Nuclear Regulatory Commission,
Washington, DC

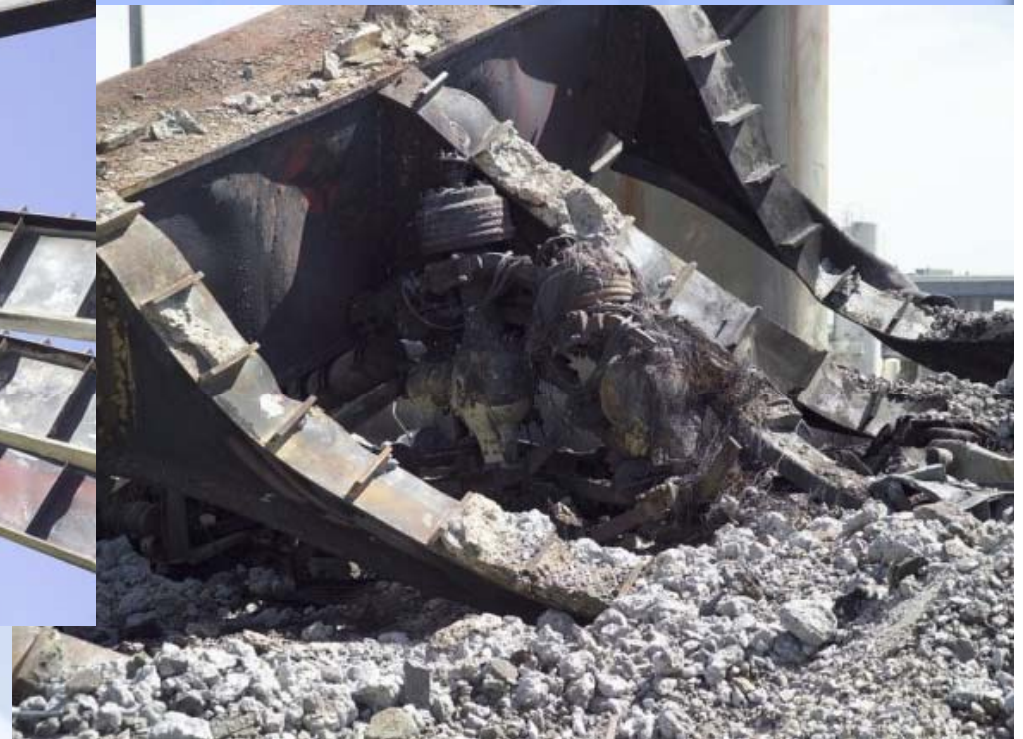
Girder cutting after concrete removal

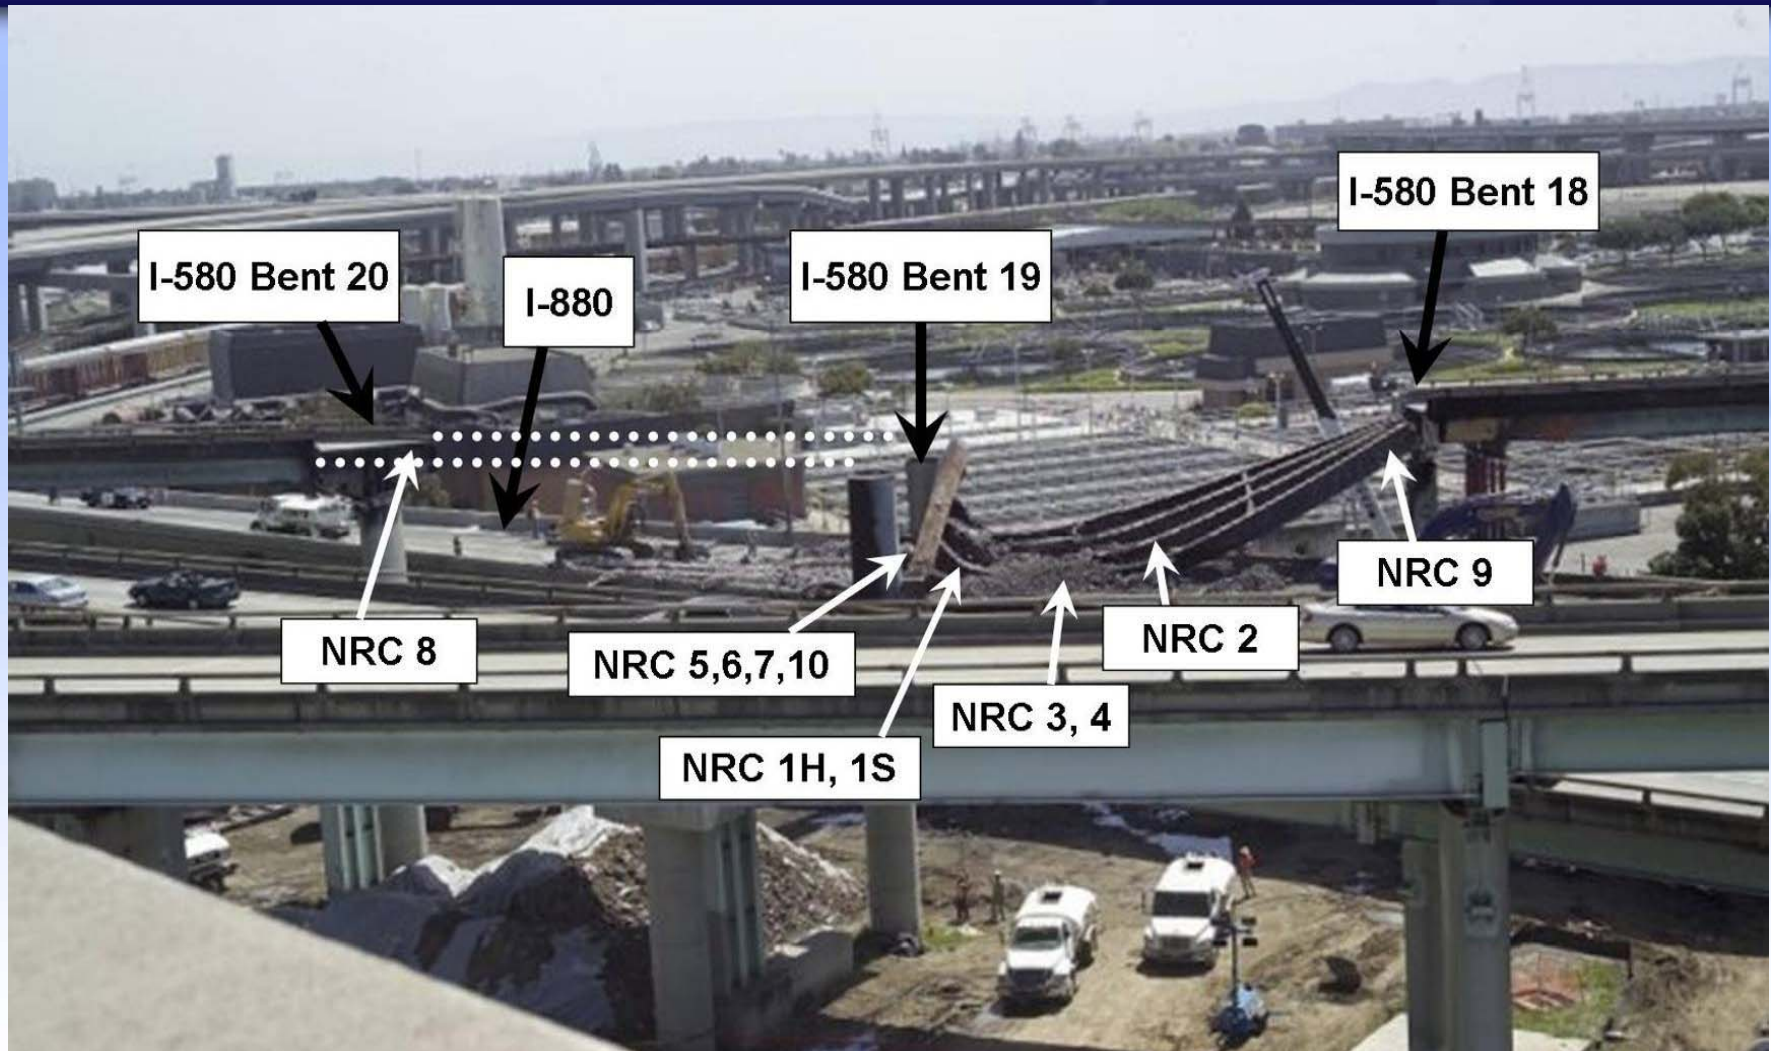
Sample Locations

<i>Sample Number</i>	<i>Girder</i>	<i>Location (Bent)</i>	<i>Weld Metal?</i>	<i>Description</i>
NRC 1H	Plate # 3	19	No	Plate Girder with rivet holes
NRC 1S	Plate # 3	19	Yes	Plate Girder with stiffener
NRC 2	Plate # 4	18 – 19	Yes	Plate Girder with butt weld
NRC 3	Plate # 5	18 – 19	Yes	Plate Girder with stiffener - heavy distortion
NRC 4	Plate # 5	18 – 19	Yes	Plate Girder stiffener - medium distortion
NRC 5	Box # 7	19	Yes	Box Girder lower plate with side and weld
NRC 6	Box # 8	19	No	Plate Girder segment attached to Box Girder
NRC 7	Box # 8	19	No	Rivet head
NRC 8	Plate # 10	20	Yes	Plate Girder Web and plate with weld
NRC 9	Plate # 12	18	Yes	Plate Girder with stiffener
NRC 10	Box # 8	19	No	Paint Flakes

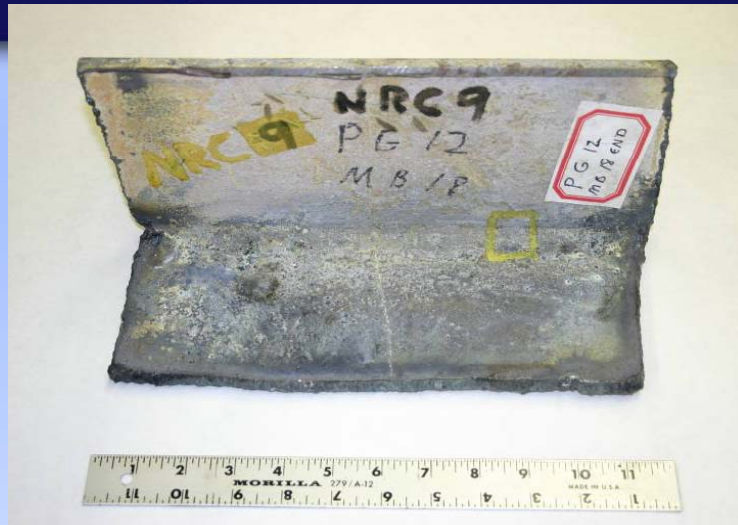
Specimens From NRC 9

- Specimens contain material from the plate girder, stiffener and plate-stiffener weld
- Thermal exposure according to prescribed matrix
- Large specimen collected for this purpose

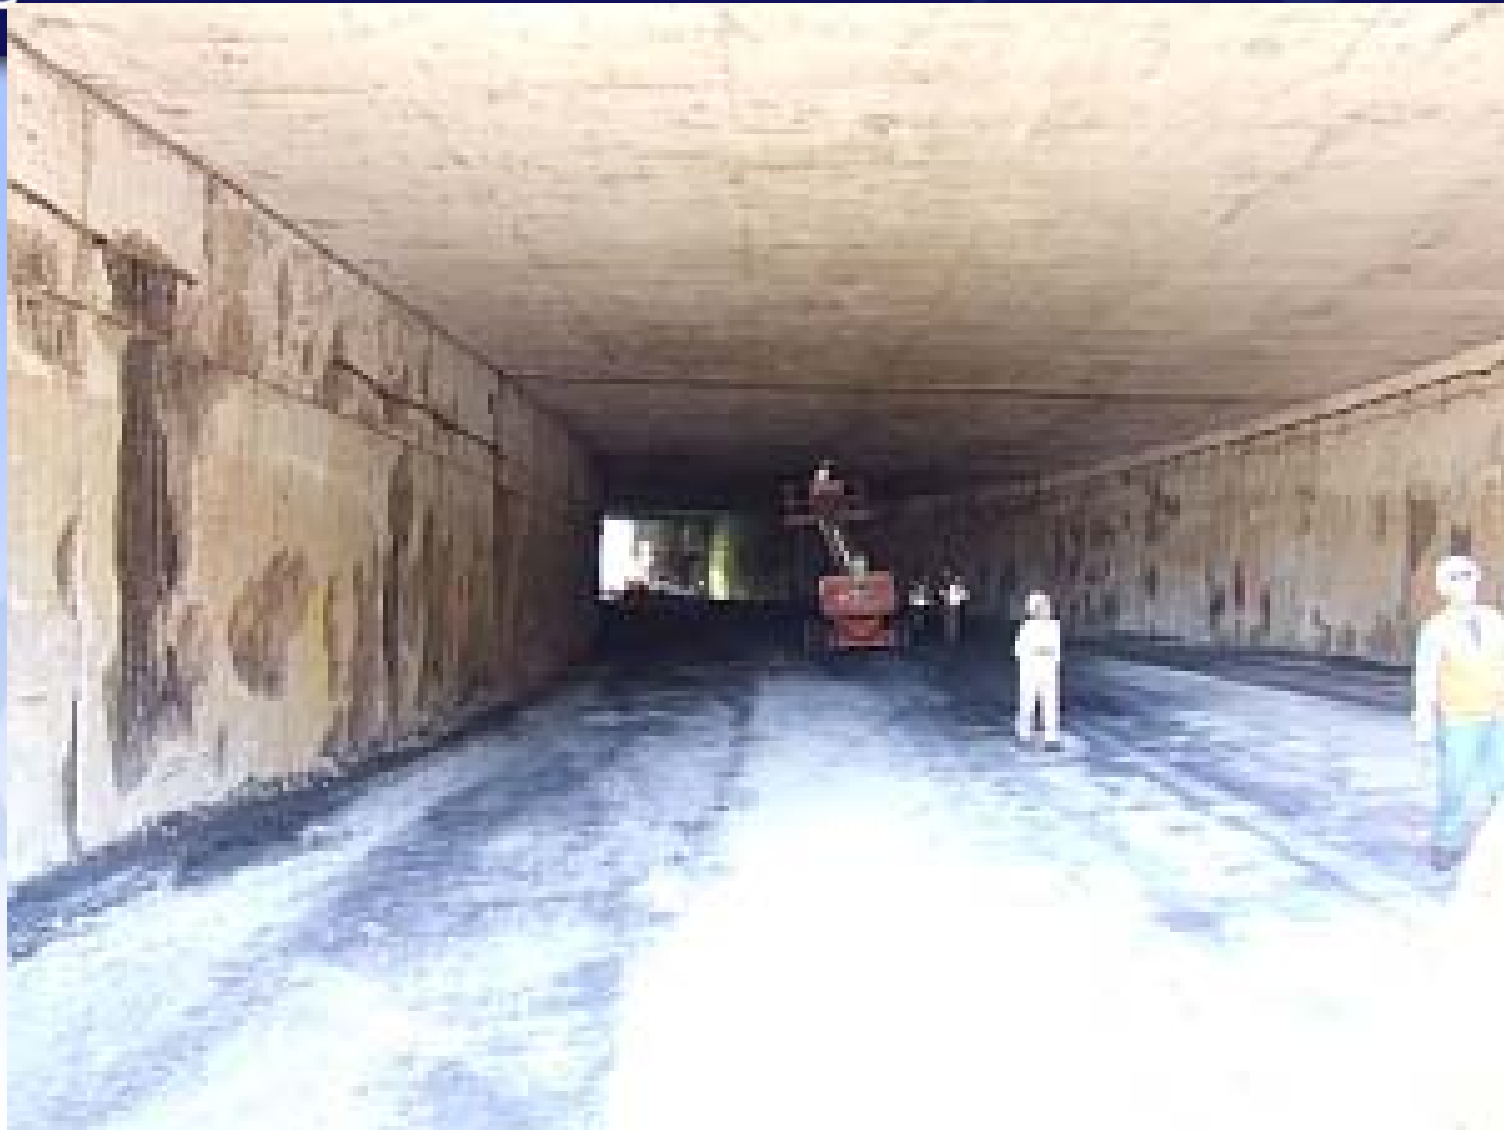
Newhall Pass Tunnel: Post-Fire

- **Temperature in the tunnel reached levels high enough to melt aluminum.**
 - greater than 560° C [1,040°F]
- **At the location of truck 17, a higher temperature was observed based on a melting point analysis.**
 - greater than 884° C [1,623°F]
- **Hardness data (from bolts) indicated temperatures between 400 and 800 °C [750 and 1,470 °F].**
- **Based materials analyses results, gas temperature varied with time and location and exceeded 884° C [1,623°F] in at least one location.**
